ADAMO GROUP DEMOLISHES FIRE-DAMAGED FACTORY IN DETROIT

PROJECT DESCRIPTIONS AND PHOTOS SUBMITTED COURTESY OF ADAMO GROUP

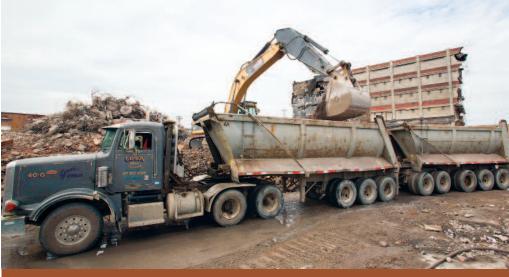
Debris removal commences at the Palmer **Promotional Products site.**

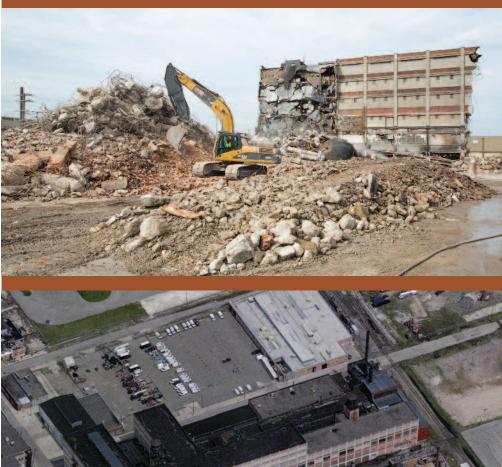
Adamo demolishes the fire-ravaged Palmer Promotional Products building.
